USAAVLABS TECHNICAL REPORT 68-30

INSPECTION, REPAIRS AND MODIFICATIONS, AND FLIGHT TEST OF THE FLEXIBLE-WING MANNED TEST VEHICLE XV-8A

J. F. MYRNE

JUNE 1968

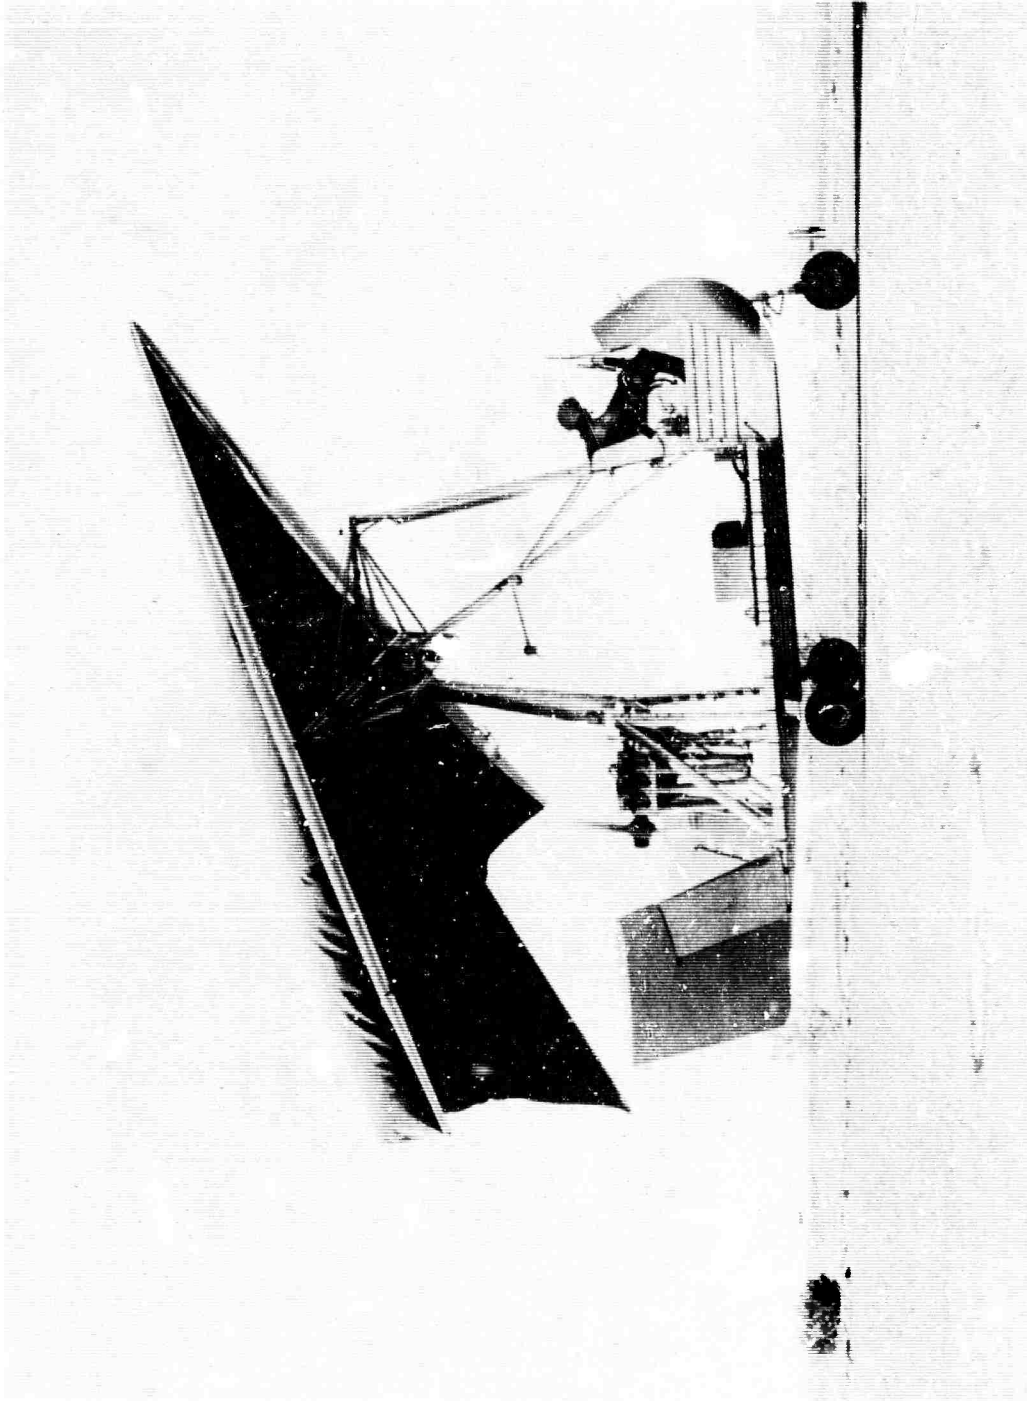
Figure 1. Flexibla-Wing Aerial Utility Vehicle, Front View

The flexible-wing aerial utility vehicle is a self-propelled flying cargo platform supported from a Rogallo-type flexible wing. (See Figures 1 and 2.)

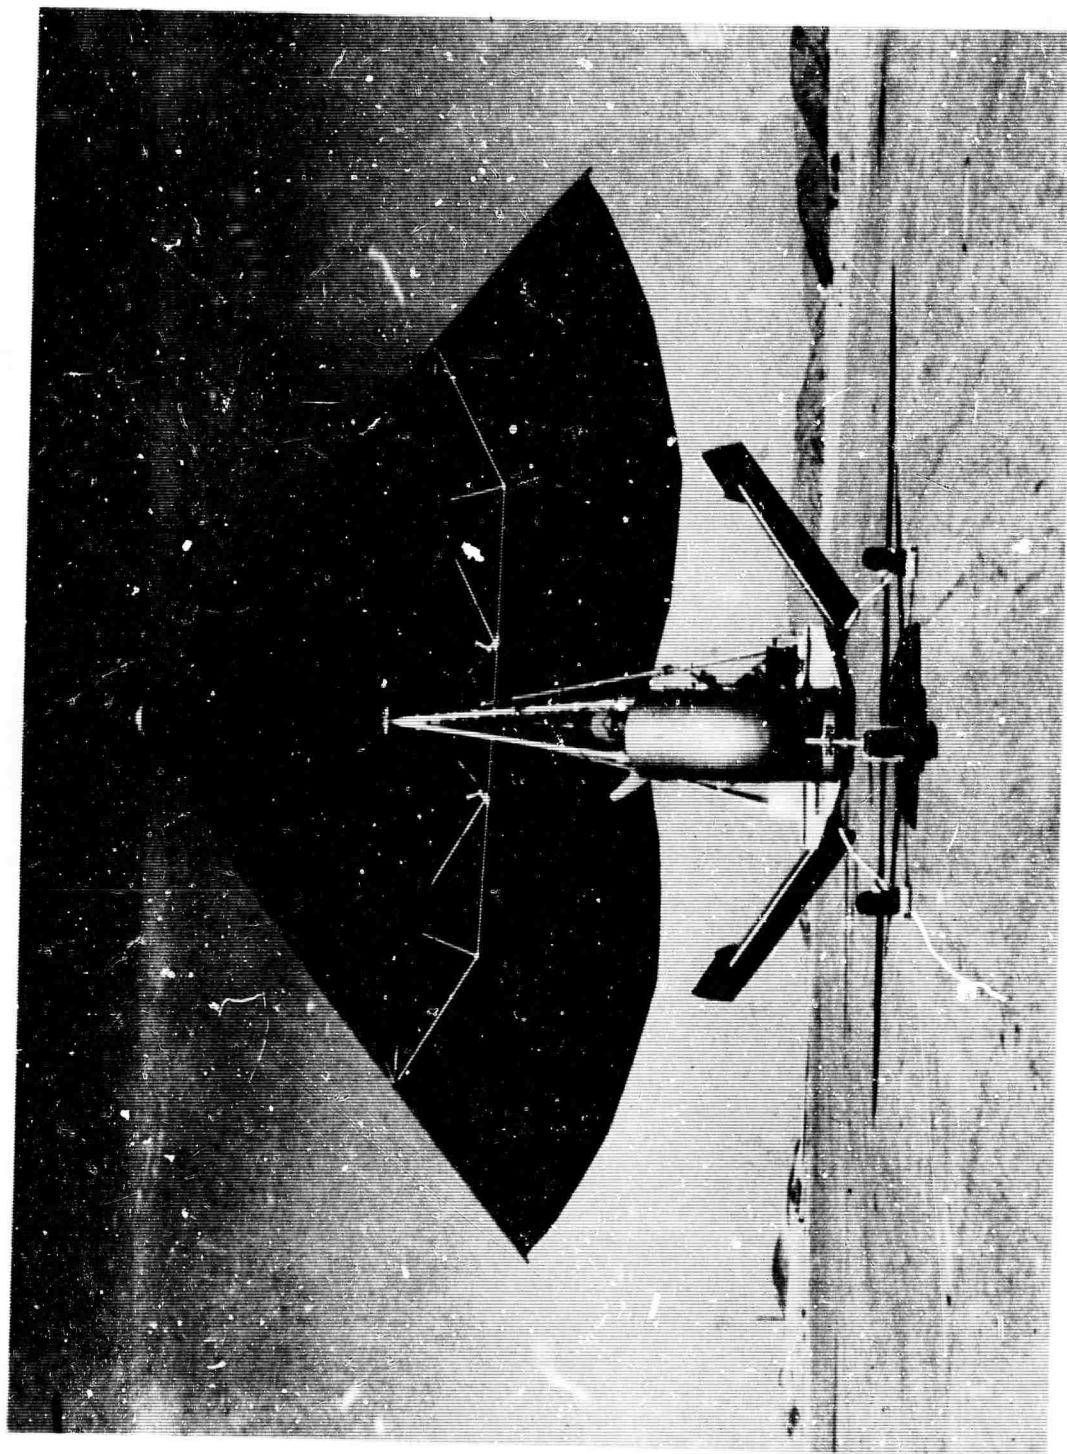
Figure 2. Flexible-Wing Aerial Utility Vehicle, Side View

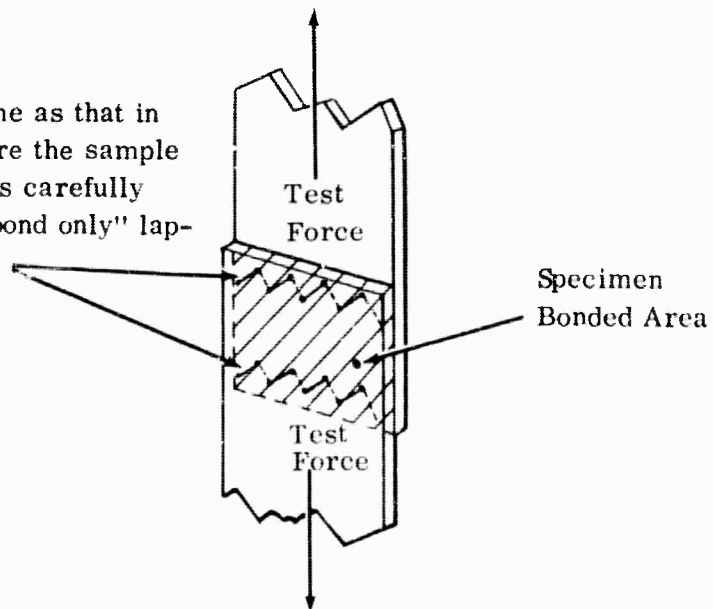
1. Tensile fabric test in accordance with Federal Specification, Textile Test Methods No. CCC-T-191, Method 5104, and ASTM D 1682-59T.
2. Lap shear strength test procedure shown in sketch below.
3. Peel test in accordance with Federal Specification, Textile Test Methods No. CCO-T-191, Method 5960.

Stitching used is the same as that in aircraft wing from where the sample was taken. Stitching was carefully removed for "adhesive bond only" lap-shear test.

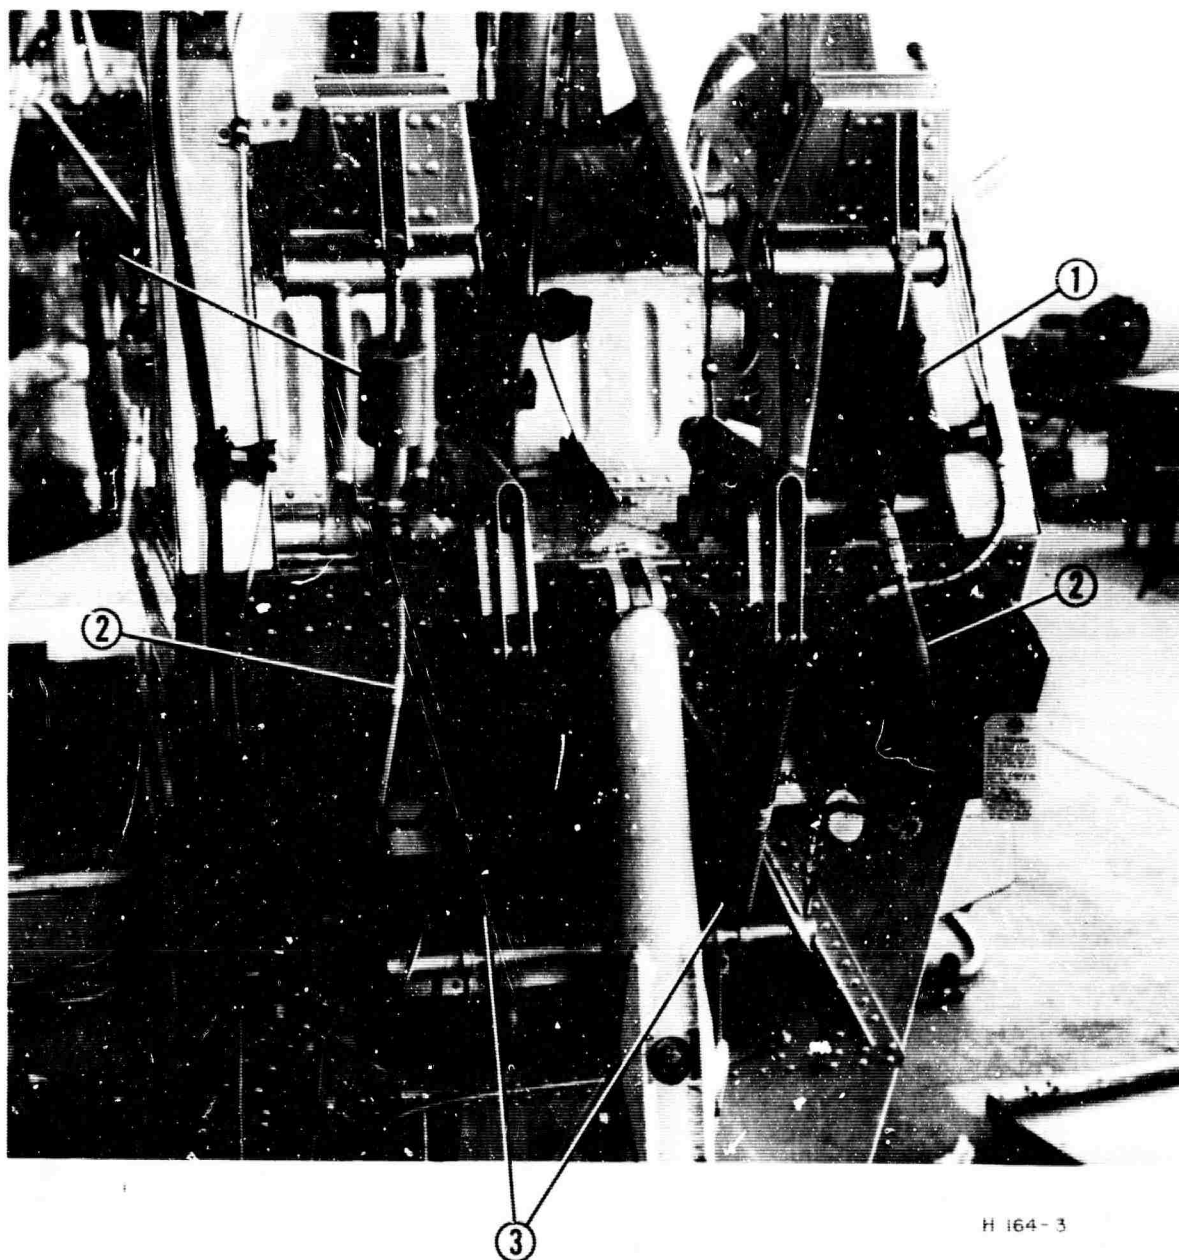
Legend: 1 - Differential Braking Cylinders
2 - Hydraulic Brake Lines
3 - Rudder Force Gradient Springs

Figure 3. Brake and Rudder Force Gradient Modifications

Differential Wheel Braking. Braking had been accomplished by applying equal braking to both wheels when the right brake pedal was depressed. Independent braking of the wheels by separate rudder pedal brake controls was needed to improve directional control on the ground, particularly in crosswinds. The modification was accomplished by simple brake pedal modification and the addition of a brake cylinder and hydraulic fluid tubing in both vehicles. See Figure 3.

Rudder Force Gradient. The aircraft inherently had very low forces that tended to return the rudder pedals to neutral in flight. Not only were dynamic pressures low, but the control surfaces were aerodynamically balanced. With the adoption of a three-control system, some "feel" was needed for the pilot through his rudder pedals in flight. The modification was accomplished by connecting springs to airframe brackets and to the rudder pedals as shown in Figure 3. To permit pilot selection, springs with three levels of gradient were used.

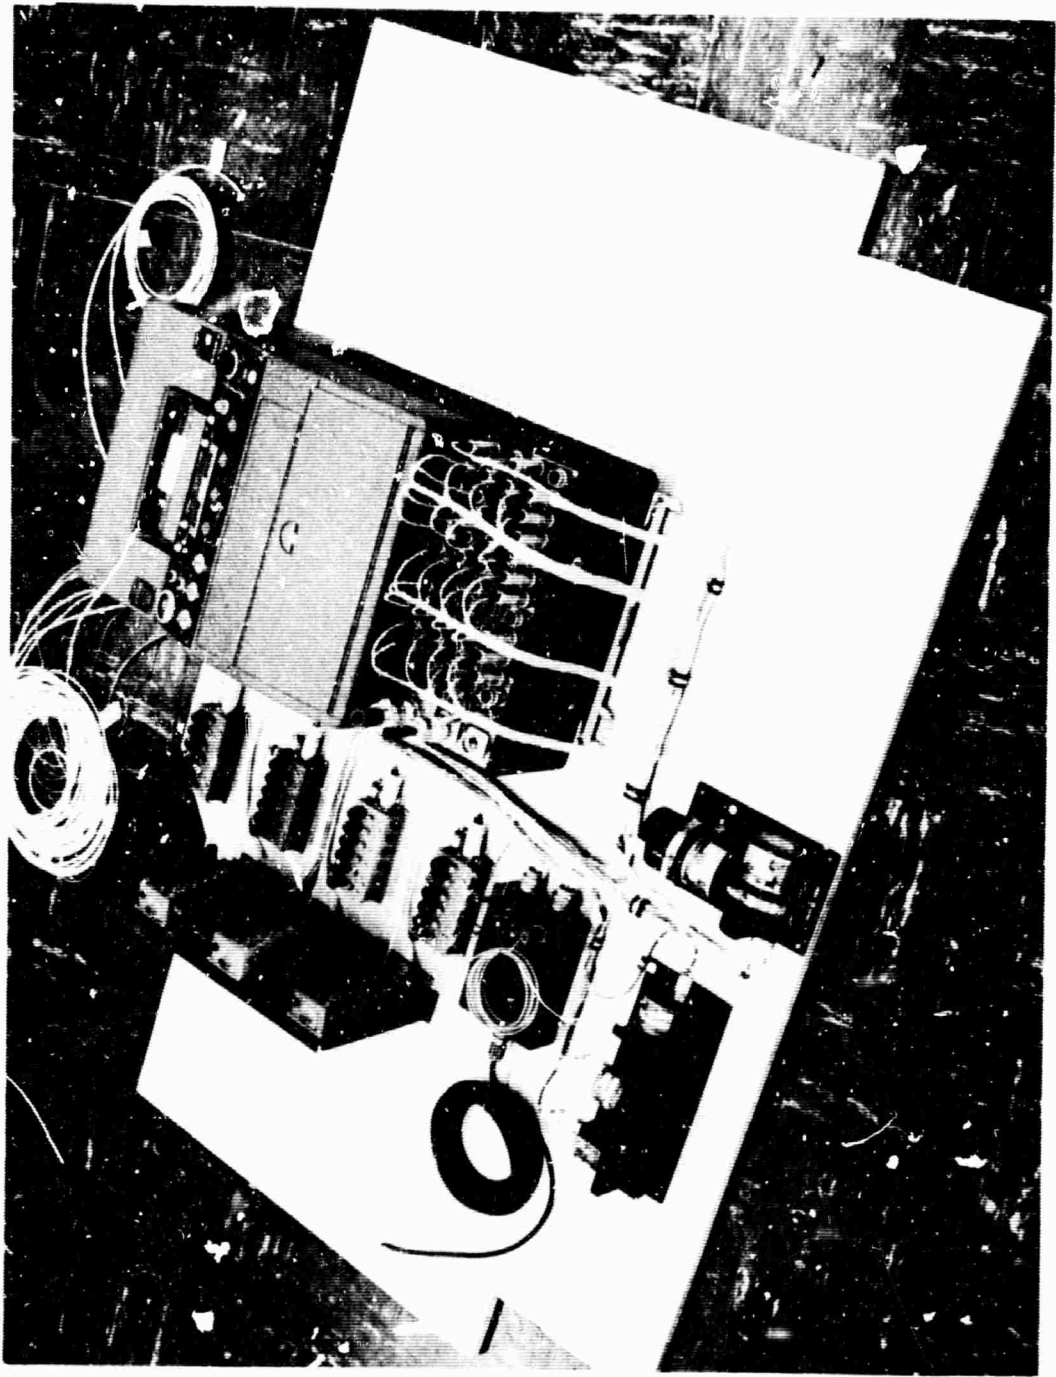
Figure 6. Palletized instrumentation, Before Installation in Vehicle

The pilot's instrument panel on aircraft 63-13003 was complete. revised prior to this program, and the addition of an electrical system included installation of new pilot-operated switches and circuit breakers. The major test instrumentation was embodied in a 50-channel recording oscillograph and a 15-instrument photopanel, both on the platform of the vehicle. Measurements included all types of parameters; e.g., attitude and structural stresses. Arrangement of instruments on the special pallet is shown in Figure 6. General arrangement and schematics are shown in Appendix III.

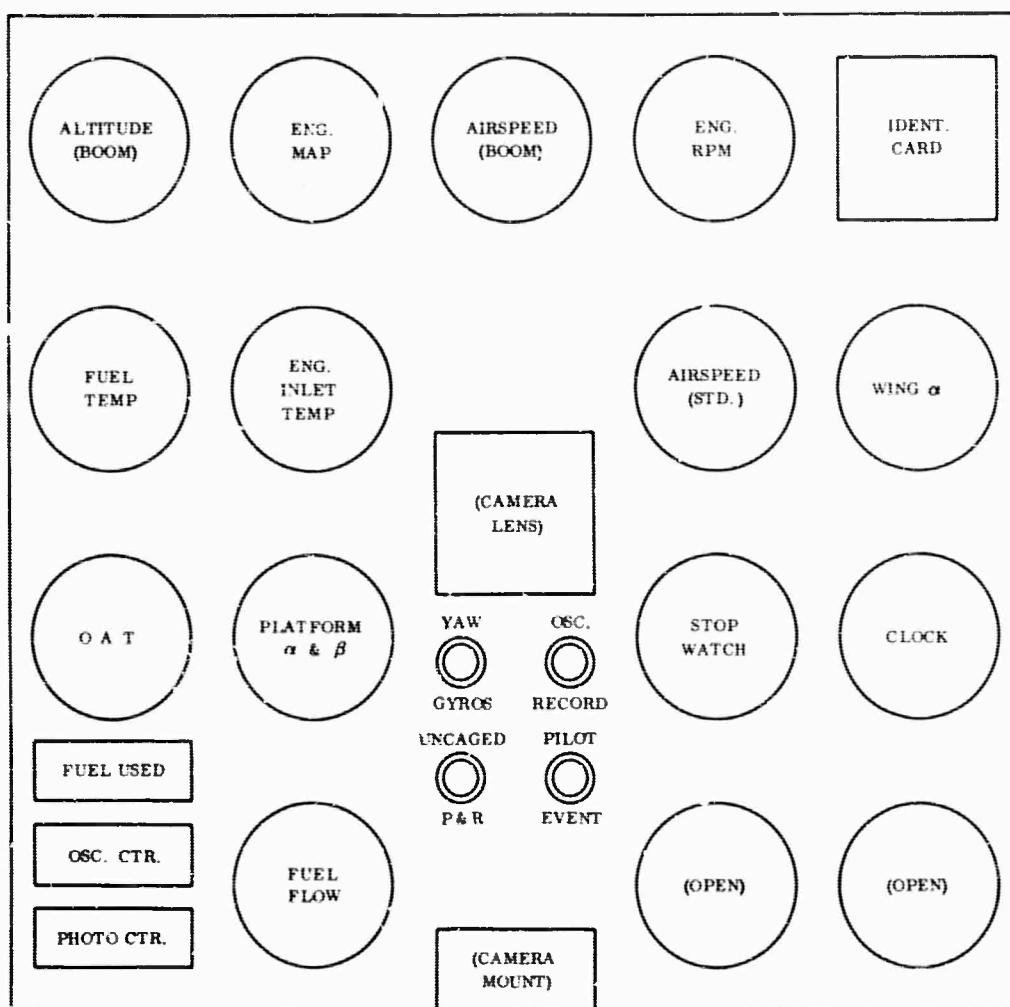
NOTE:
INSTRUMENT LOCATIONS FROM
BACK SIDE OF PANEL LOOKING FWD.

Figure 7. Photopanel Layout

A photopanel layout and a layout of the pilot's panel are provided as Figures 7 and 9. Table V shows oscillograph assignments.

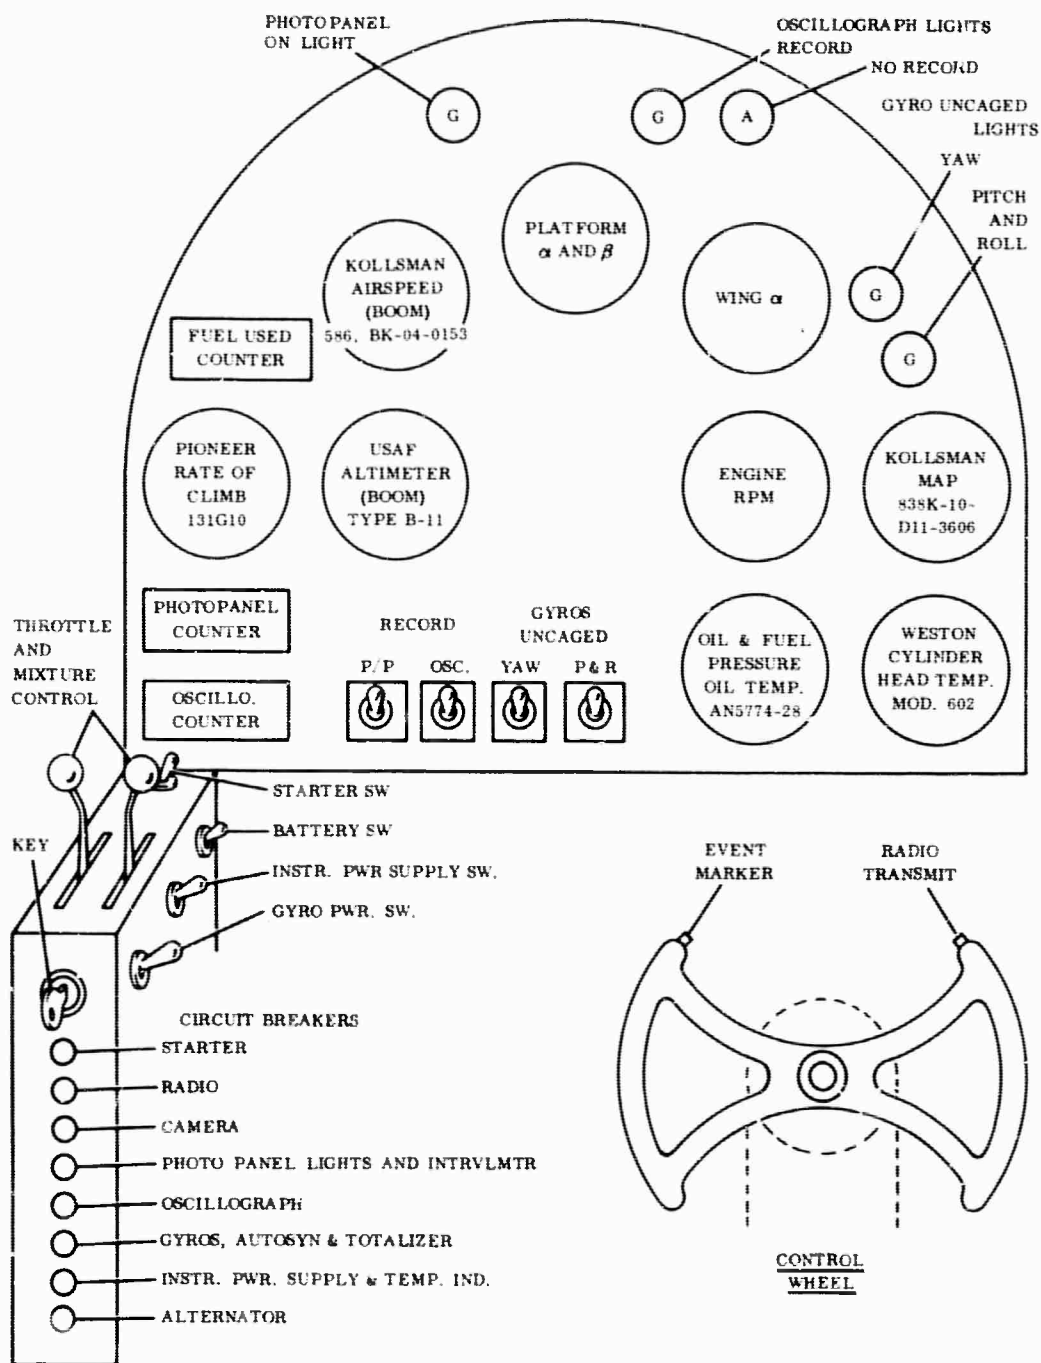
Figure 8. Pilot's Panel Arrangement

The instrumentation system presented in Figure 8 proved to be outstanding in its brief period of usage. With a solid basic design and installation, good records were obtained on the first as well as succeeding test operations.

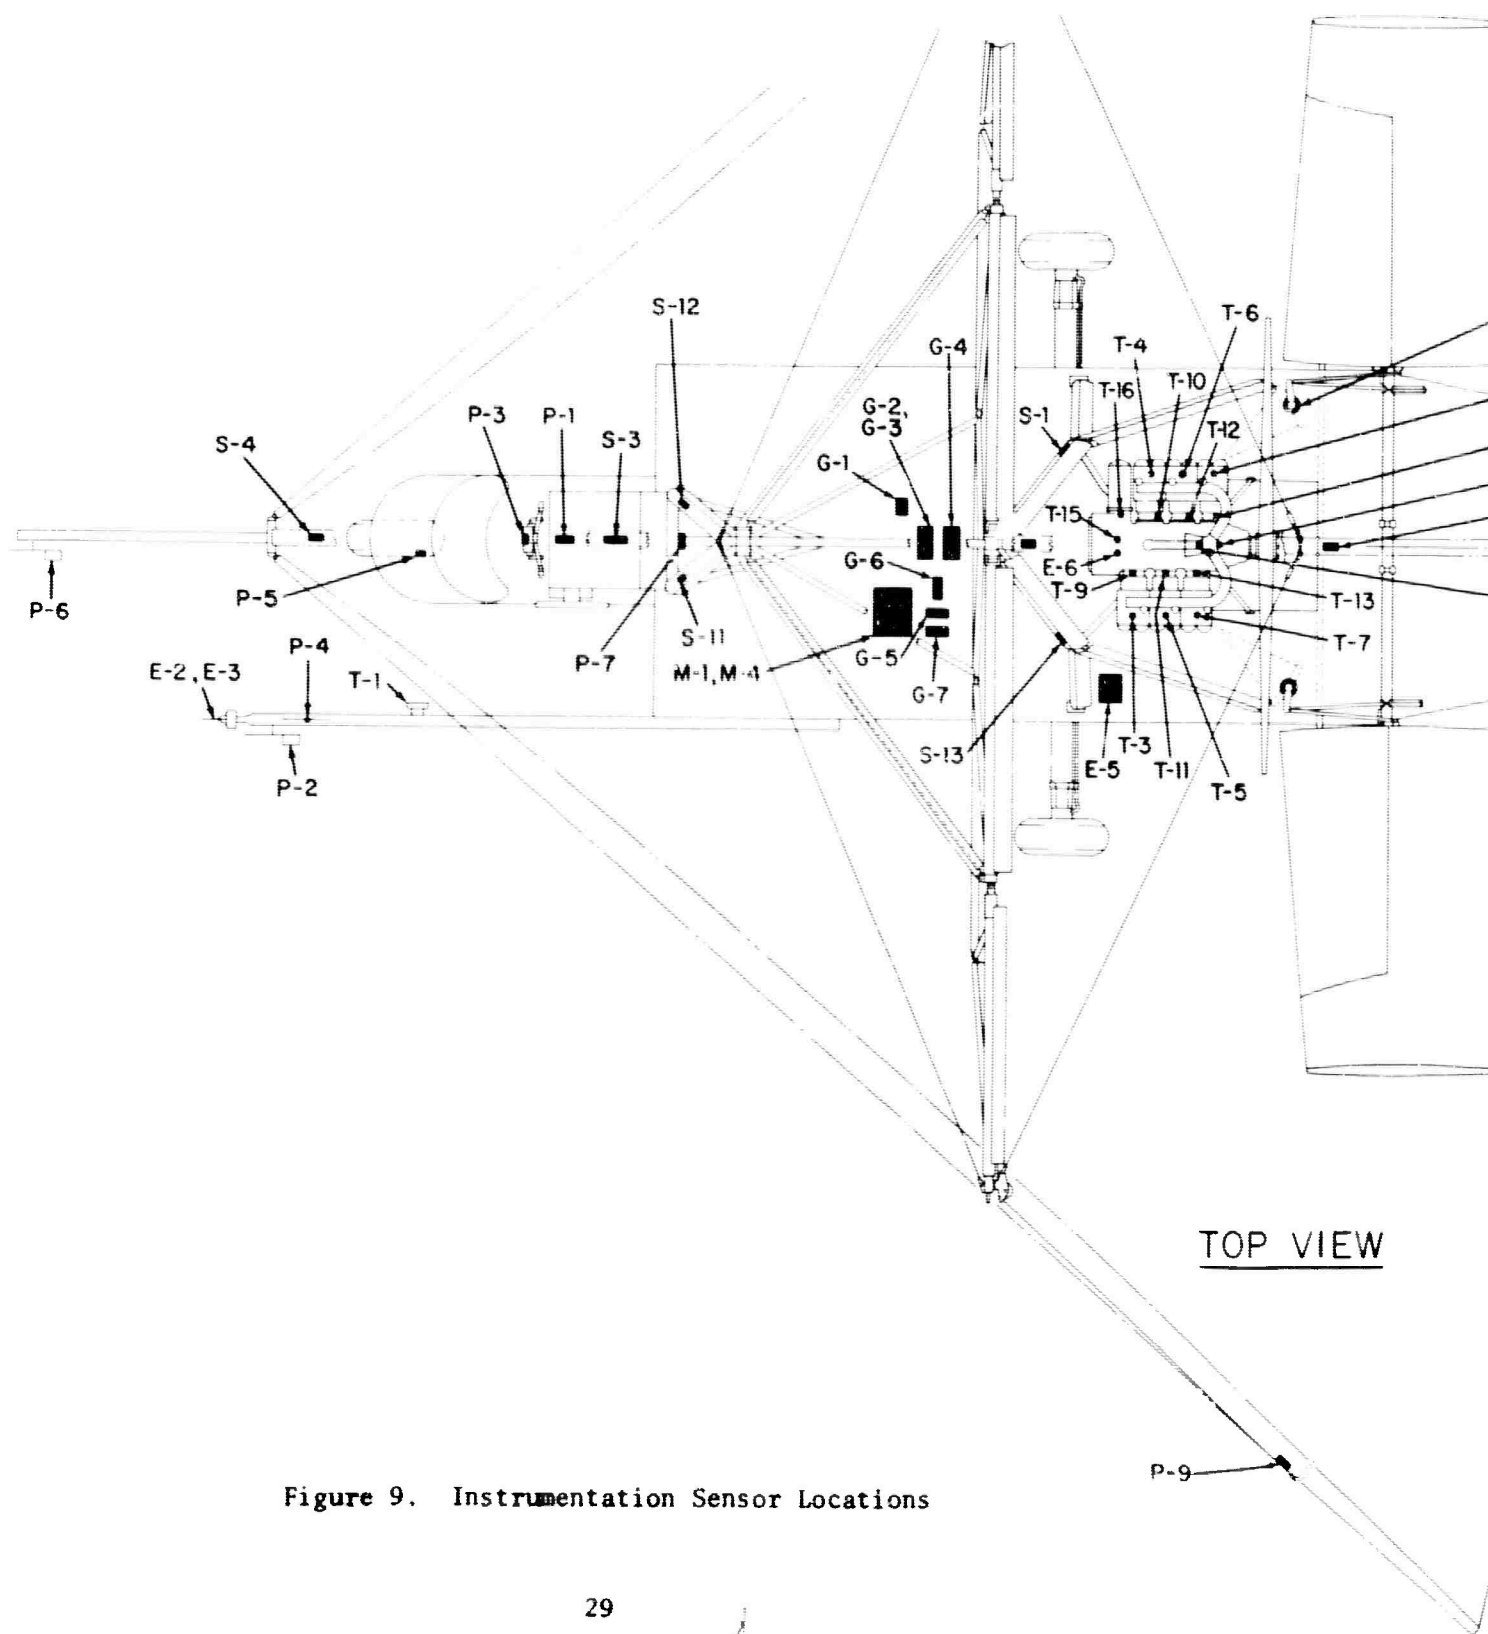
Figure 9. Instrumentation Sensor Locations

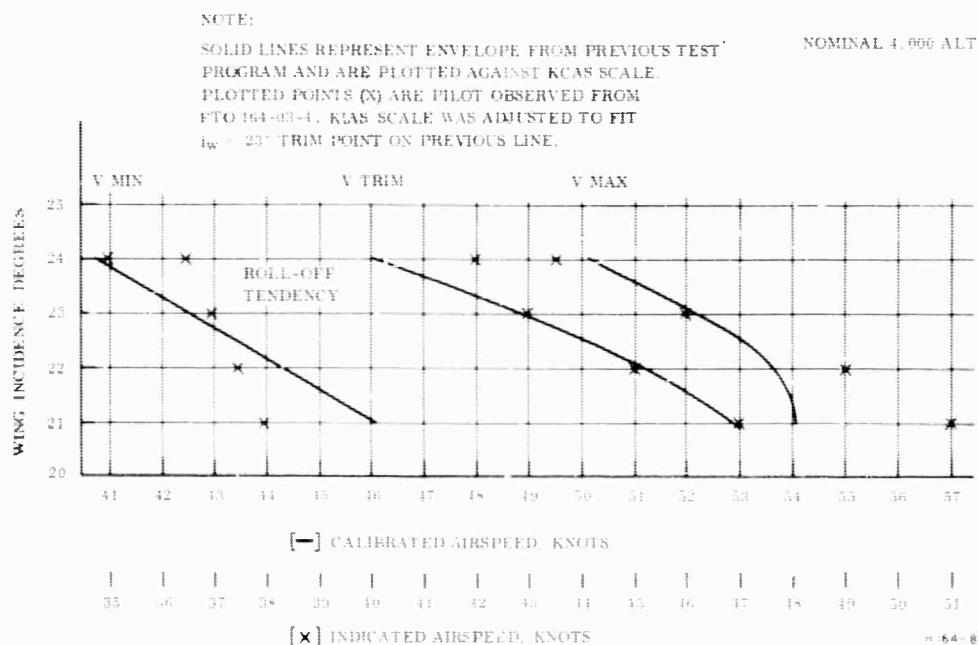
Figure 10. Flight Envelope for 2300 Pounds Gross Weight and Mid-C.G.

Flight Envelope. Data were obtained on the mid c.g., design gross weight flight envelope in FTO 164-03-4. Figure 10 shows the pilot-observed points in comparison with the trim and limit speed lines obtained in the previous test program. The airspeed scales were adjusted as indicated on the plot. Minimum speeds were obtained with near-full-aft stick (not on aft stop) and above a speed with any roll-off tendency. Control forces were noted to be heavy in the aft stick position. Maximum speeds were limited by full forward stick under the aileron oscillation limit. On one previous flight, an aileron oscillation had been triggered at 52 to 52.5 KIAS by a wind gust.

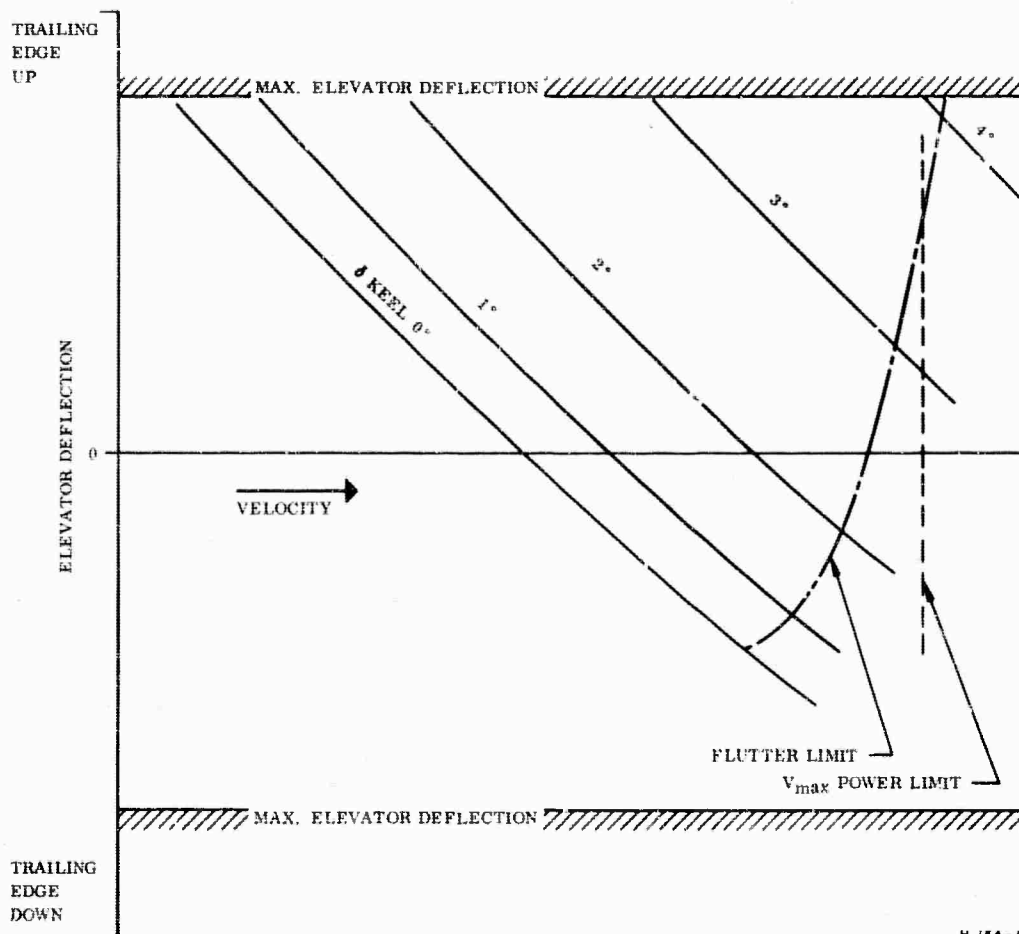
Figure 11. Change in Elevator Deflection Required for Trim When Keel Deflection is Used to Reduce Membrane Ripple

characteristics may be determined from tests which result in a diagram similar to that shown in Figure 11. This shows the change in elevator deflection required to trim caused by deflection of the keel to control flutter. To test keel tip deflection as a flutter control, the existing aircraft could be modified to include a hinged keel section operated by a wheel control similar to that used at present for incidence adjustment. Various keel tip deflections could then be tested to determine the flutter boundary as a function of C_L , q , and keel deflection.
